Date: 09/13/00

Re: Aspen CDP Board Rev. 1.3 - Board Issues/Errata

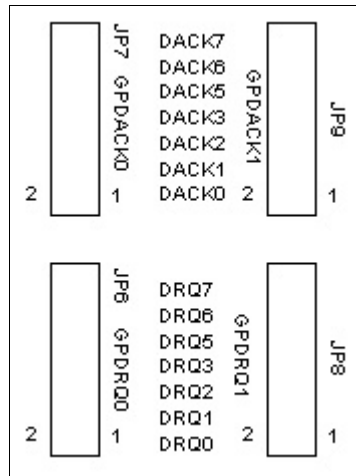
Figure 1

Problem The silkscreen for JP6, JP7, JP8, and JP9 is incorrect.

The signals DRQ0, DRQ1, DRQ2, and DRQ3 on JP6 and JP8 are incorrectly labeled as DRQ1, DRQ2, DRQ3, and DRQ4 respectively.

The signals DACK0#, DACK1#, DACK2#, and DACK3# on JP7 and JP9 are incorrectly labeled as DACK1#, DACK2#, DACK3#, and DACK4# respectively.

The labels ISA1 and ISA0 that identify the JP6/JP7 and JP8/JP9 jumper blocks are incorrect. They should be removed entirely.

JP6 should be labeled GPDRQ0, JP7 should be labeled GPDACK0, JP8 should be labeled GPDRQ1, and JP9 should be labeled GPDACK1.

Relabel the jumper headers. Refer to figure 1.

Change the silkscreen to correct the labeling error. It should appear exactly as the schematic indicates with the top-down view on page 15 (with the exception of the ISA0 and ISA1 labels being removed and the GPDACK0, GPDACK1, GPDRQ0, and GPDRQ1 labels being added). Refer to figure 1.

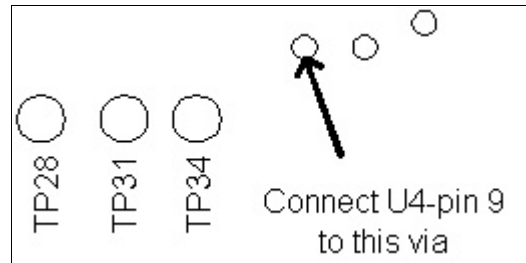
Problem DMA from the IDE interface does not work. The data transceiver, U23, is not enabled by the PAL, U4, during an IDE DMA transfer. In addition, the IDE Data Bit 7 is not activated properly during a DMA cycle.

To fix this problem, the PAL needs a signal indicating that an IDE DMA cycle is in progress. The equations for the data transceiver enable outputs on the PAL must be changed to activate the enable signals during an IDE DMA cycle. In addition, the IDE Data Bit 7 must be properly activated for read or write during an IDE DMA cycle.

Cut trace from the VIA to U4-pin 9.

Wire from the via indicated in Figure 2 to U4-pin 9. This puts the signal IDE DACK# onto pin 9 of the PAL for use in the equations.

(This step is an alternative to the previous step, either connect from the via or from the backside of the board, but not both.) Wire from P4-pin 20 to U4-pin 9. Run the wire through the hole in the board for TP32, which is located right next to U4.

Reprogram the PAL with the Revision 1.3 Equations (*see rework 1.3.4*), which adds terms for asserting the missing IDE signals whenever IDEDACK# is asserted.

Delete the signal GPAEN from the U4 PAL and instead put the signal IDEDACK# onto pin 9.

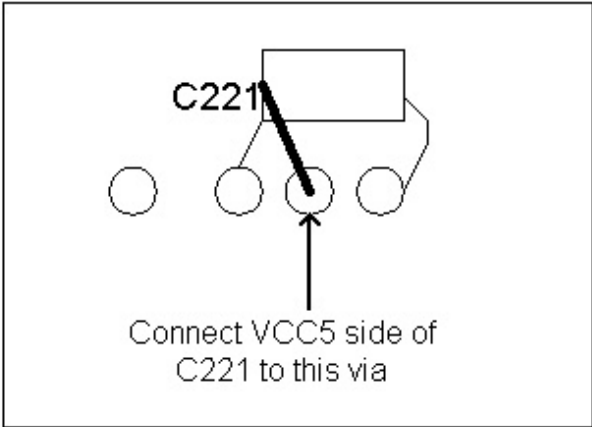
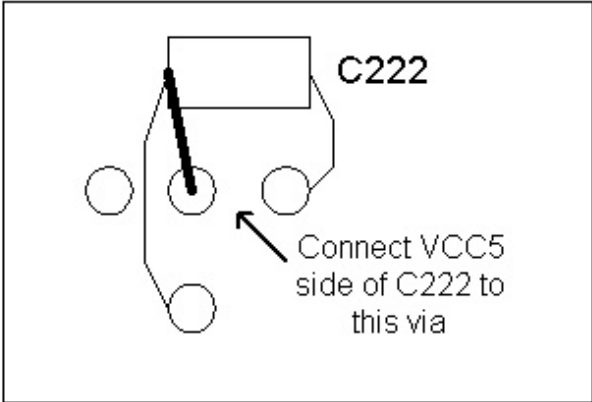
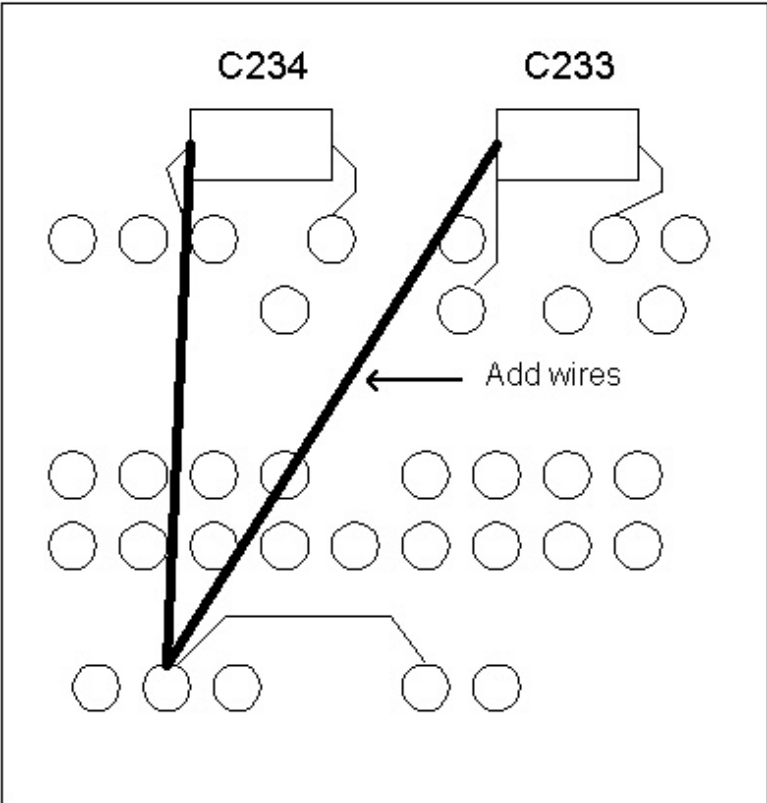
Figure 3

Problem 16 of the 32 memory data signals are not visible on the SDRAM Header. The buffer (U44) that is connected between the SDRAM header (P7) and these signals is not connected to VCC5.

Pins 7, 18, 31, and 42 on U44 are connected to C221 and C222 through a trace that spans across the entire board. U44 should be utilizing C233 and C234 as its source of filtered power, as they are located near U44. The VCC5 side of these capacitors should be connected directly to pins 7, 18, 31, and 42 of U44 through a via. The VCC5 side of C221 and C222 should be connected to pins 7, 18, 31, and 42 of U43 (a buffer for the PCI Header) through a via, as they are local to that chip and should be used to filter its power.

Wire from U44 pin 42 via to VCC5 side of C233 and C234.

Wire from U43 pin 18 via to VCC5 side of C221.

Wire from U43 pin 42 via to VCC5 side of C222.

Connect VCC5 to C221, C222, and U44 pins 7, 18, 31, and 42.
