Revision Guide for AMD Athlon™ 64 and AMD Opteron™ Processors

Publication # 25759	Revision: 3.79
Issue Date: July 2009

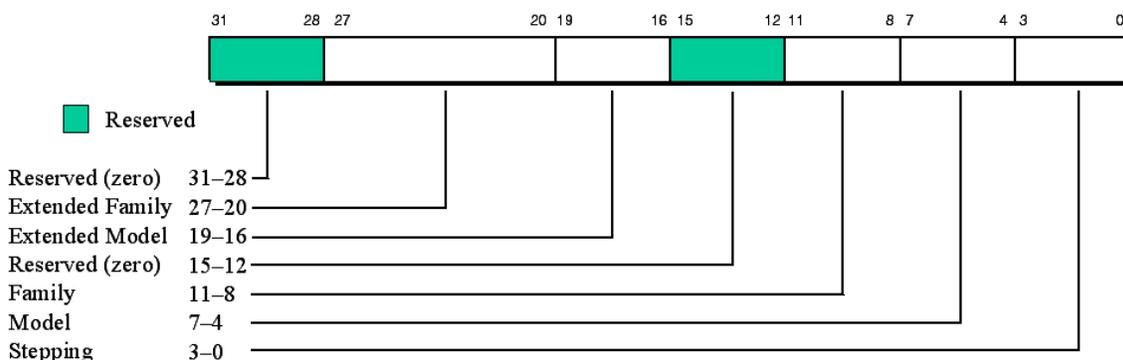
Figure 1 shows the format of the value returned in EAX by CPUID Function 1.

Figure 1. Format of CPUID Value Returned by Function 1
