Publication # **56323** Revision: **1.01** Issue Date: **April 2023**

Revision Guide for AMD Family 17h Models 30h-3Fh Processors

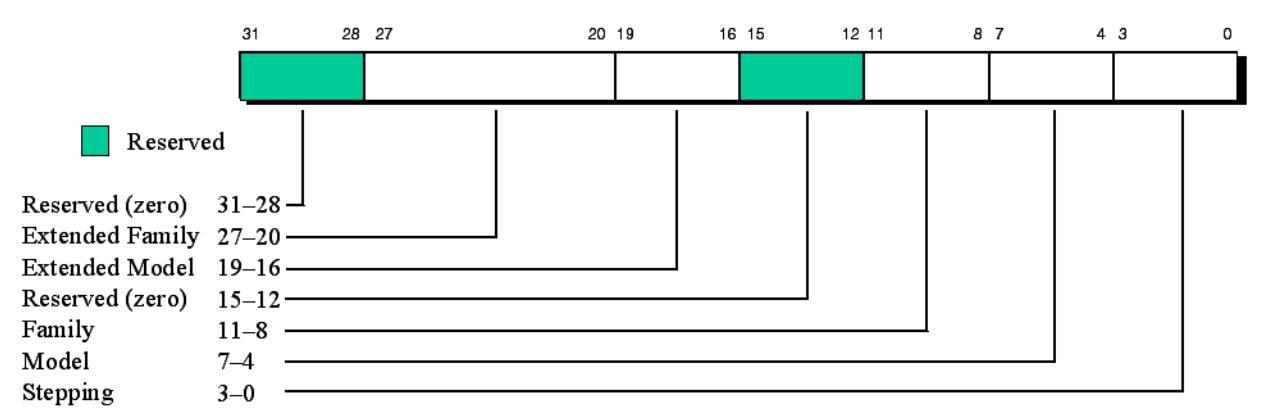
Figure 1. Format of CPUID Fn0000_0001_EAX

A processor revision is identified using a unique value that is returned in the EAX register after executing the CPUID instruction function 0000_0001h (CPUID Fn0000_0001_EAX). Figure 1 shows the format of the value from CPUID Fn0000_0001_EAX.
